1. AGENCY USE ONLY (Leave Blank)	2. REPORT DATE March 1996	3. REPORT TYPE AND DATES COVERED Final Technical Report 010992 - 290296		
4. TITLE AND SUBTITLE Damage and Failure Behavior of SiC SCS-6/Timetal 21S Metal Matrix Composite		5. FUNDING NUMBERS FQ8671-9201544 2302/BS <i>92-C-0063</i>

6. AUTHOR(S) D. A. Shockey, S. W. Kirkpatrick, C. G. Schmidt, and T. Kobayashi				
7. PERFORMING ORGANIZATION NAME(S) AND ADDRESS(ES) SRI International 333 Ravenswood Avenue Menlo Park, CA 94025-3493		8. PERFORMING ORGANIZATION AFOSR-TR-96 <i>0250</i>

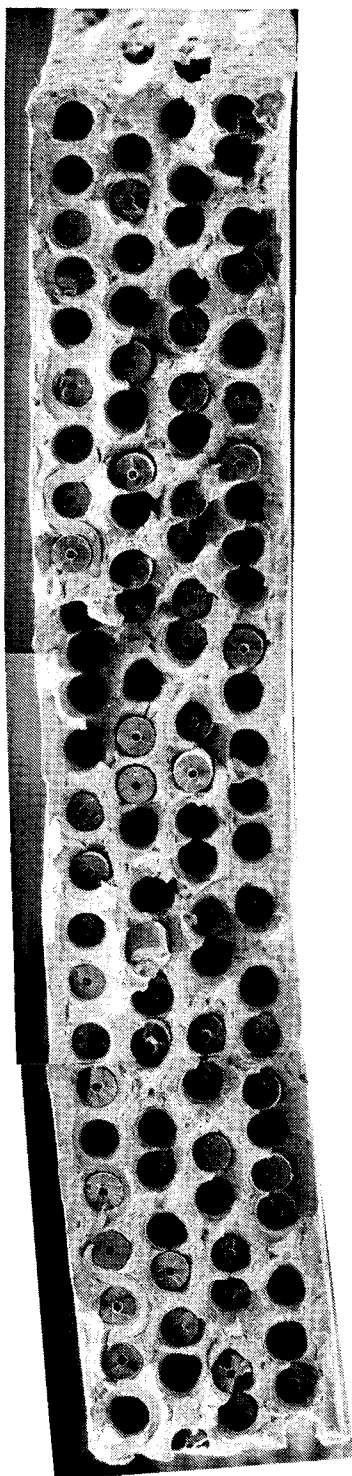
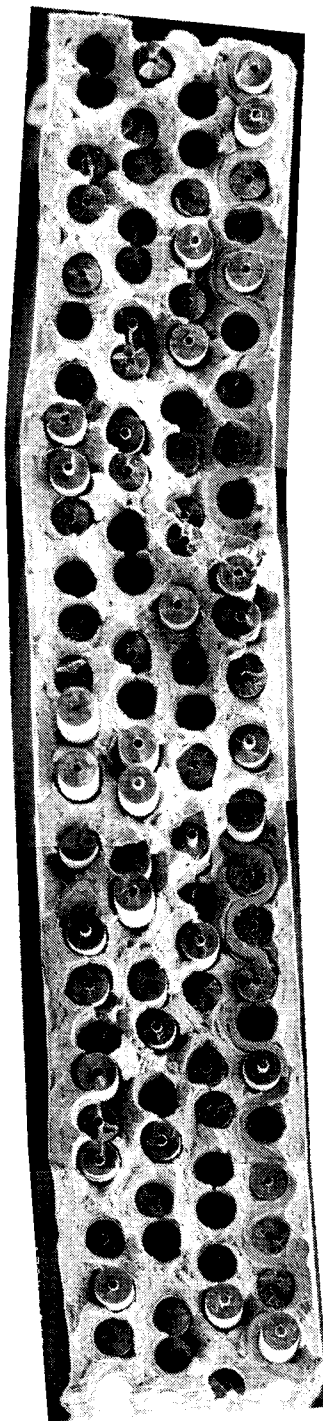
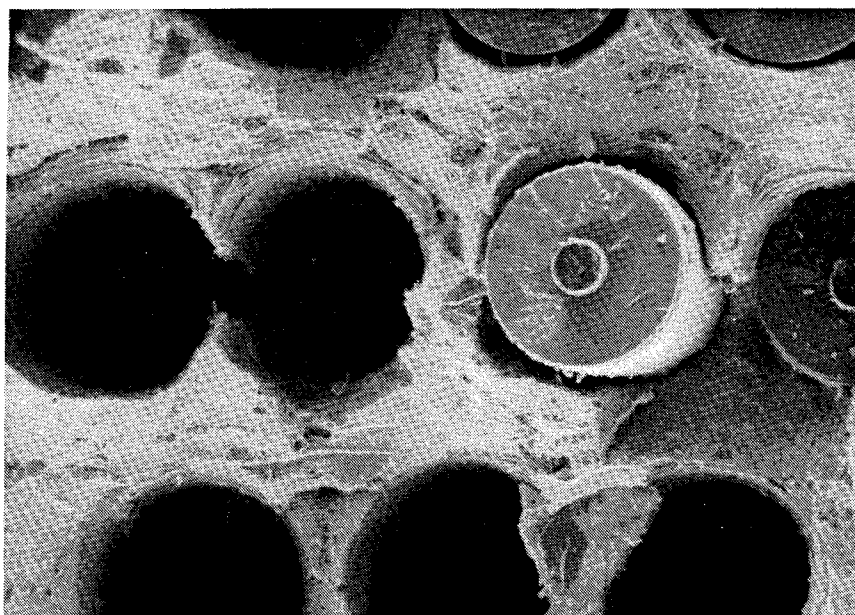
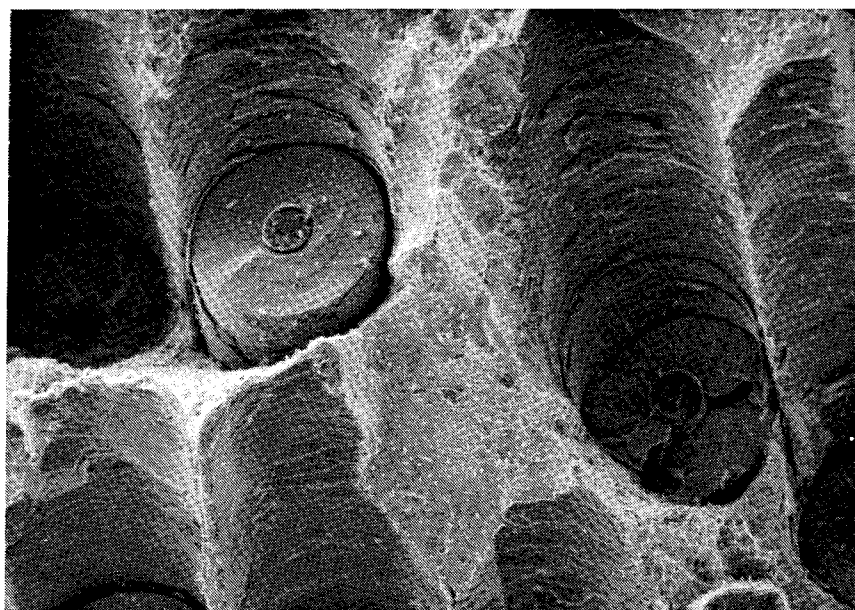
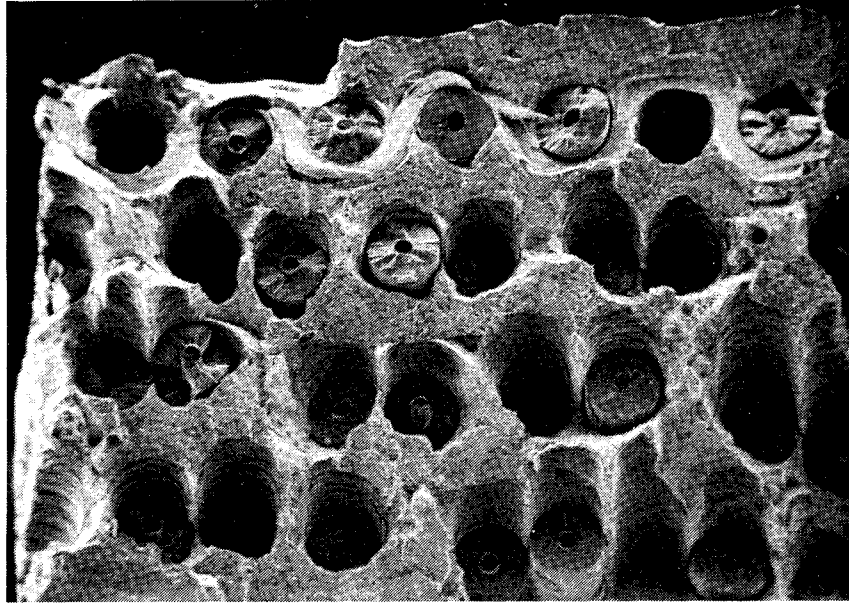
(a) Side A

(b) Side B

Figure 2.1. SEM micrographs of the fracture surfaces from the 23°C tensile test of Specimen 91-254.

(c) Orthogonal high magnification view of area on Side A

(d) Angled high magnification view of area on Side A

(e) High magnification view showing molybdenum fiber

Figures 2.1 and 2.2 show scanning electron microscope (SEM) micrographs of fracture surfaces from $[0]_4$ tensile specimens tested at 23° and 815°C, respectively. The fracture surface of the matrix component of the specimen tested at 23°C (Figure 2.2) exhibits the features of a material that failed in a ductile manner; however, in one of the composite plies, remnants of a molybdenum wool fiber is clearly evident (see Figure 2.1e). Evidence of the fiber appears on both sides of the fracture surface. An X-ray energy dispersive spectrometer (EDS) analysis of the wool fiber indicated that its composition is high in molybdenum (see Table 2.2). The measured compositions of the matrix and the fiber are consistent with the nominal compositions of Timetal 21-S and SiC, respectively.

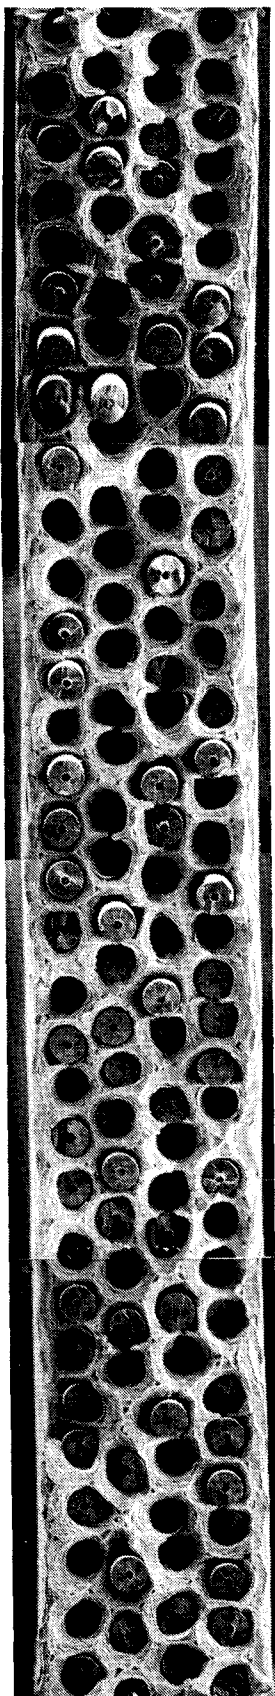
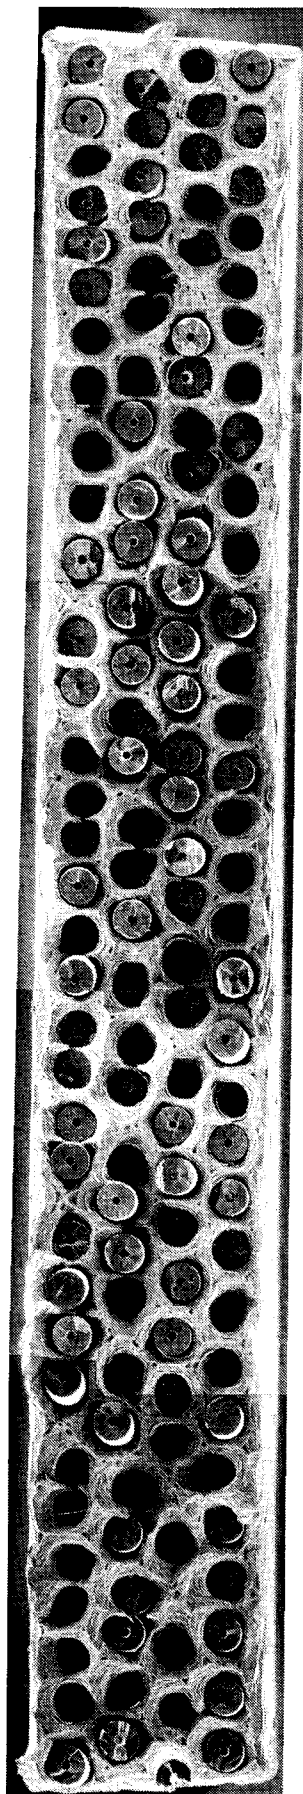
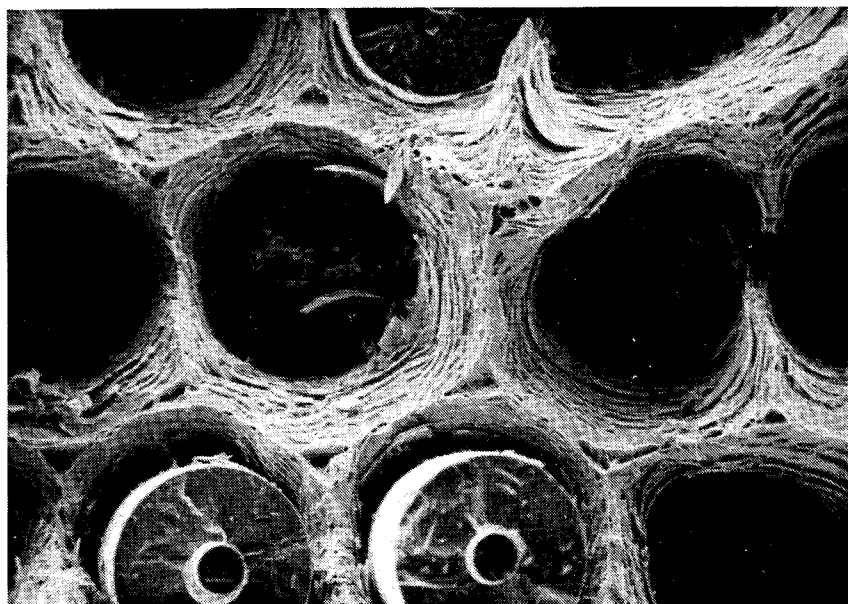
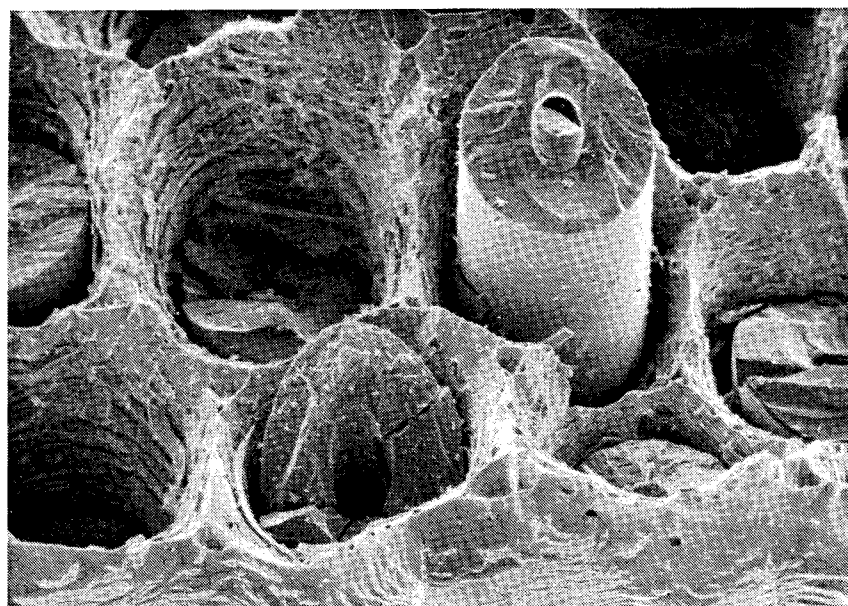
(a) Side A

(b) Side B

Figure 2.2. SEM micrographs of the fracture surfaces resulting from the 815°C tensile test of Specimen 91-247.

(c) Orthogonal high magnification view of area on Side A

(d) Angled high magnification view of area on Side A

The appearance of the matrix material on the fracture surface of the $[0]_4$ tensile specimen tested at 815°C shows greater ductility than the fracture surfaces from the 23°C test. To better compare the differences between the specimens tested at these two temperatures, a scanning laser microscope was used to topographically characterize representative regions of the fracture surfaces from tensile specimens tested at 23° and 815°C, as shown in Figure 2.3. Figure 2.4 compares the fracture surface profile of the matrix material between two fibers in 23° and 815°C test specimens. The fracture surfaces of the matrix from the 23°C test are relatively flat and at an angle that

suggests a ductile shear dominated failure process. The fracture surface of the matrix material in the 815°C test indicates a ductile necking type of failure.

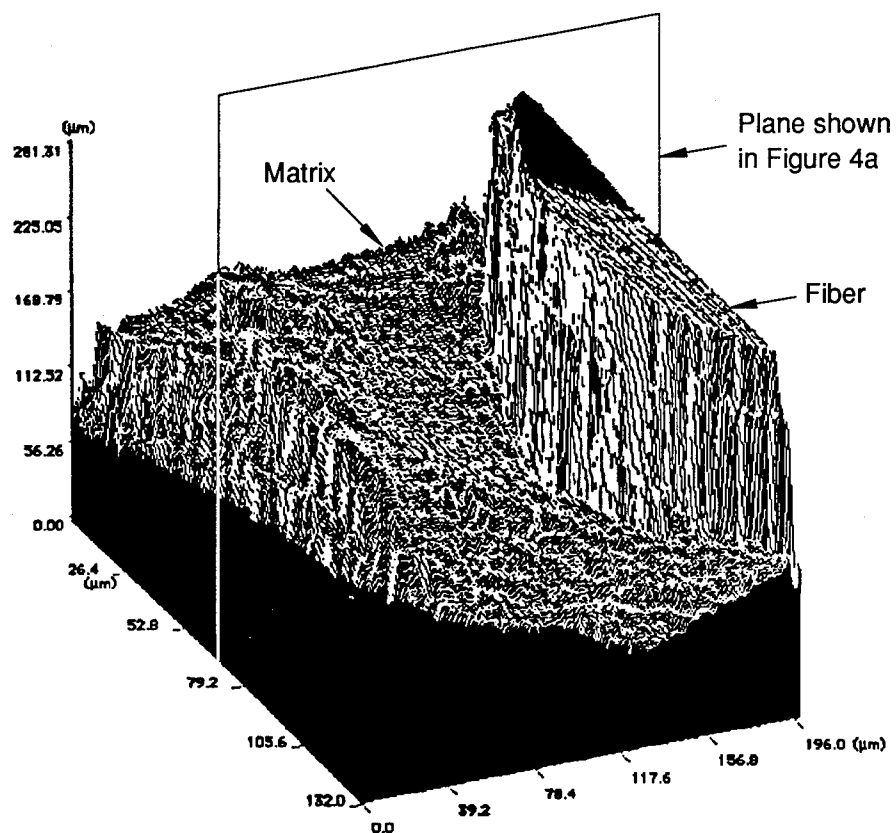
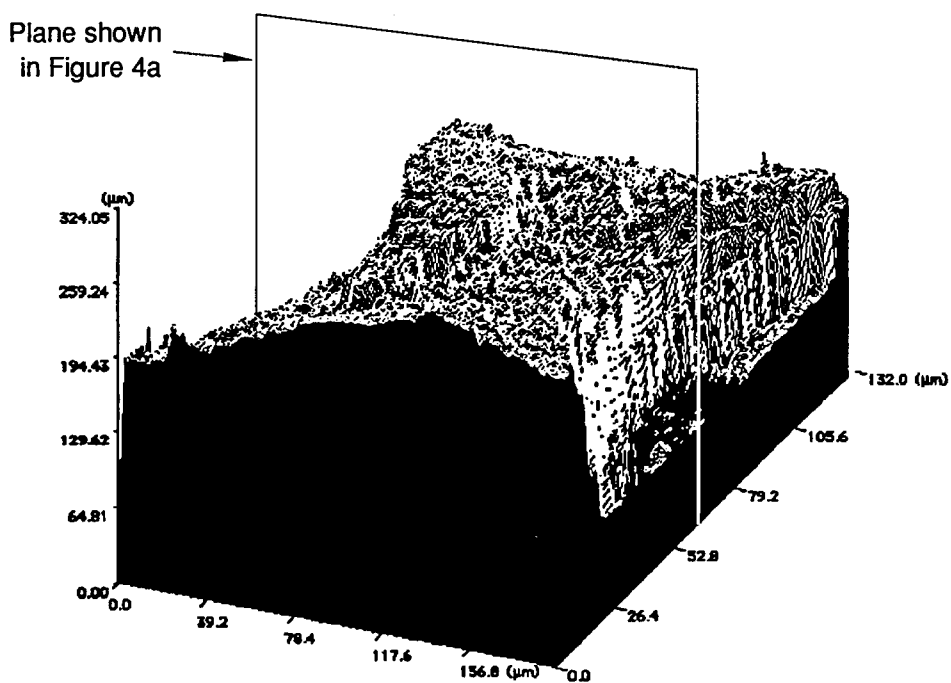
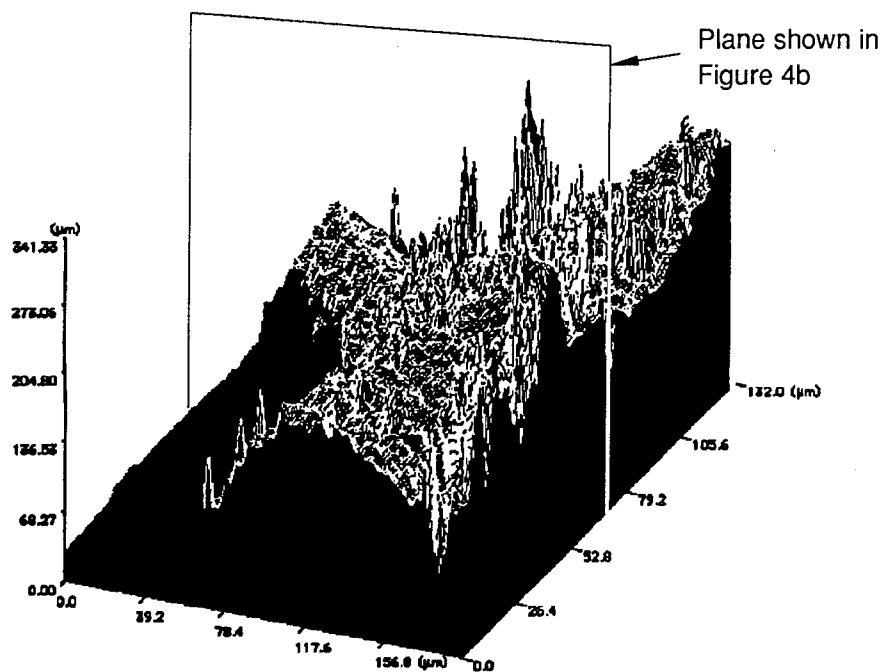
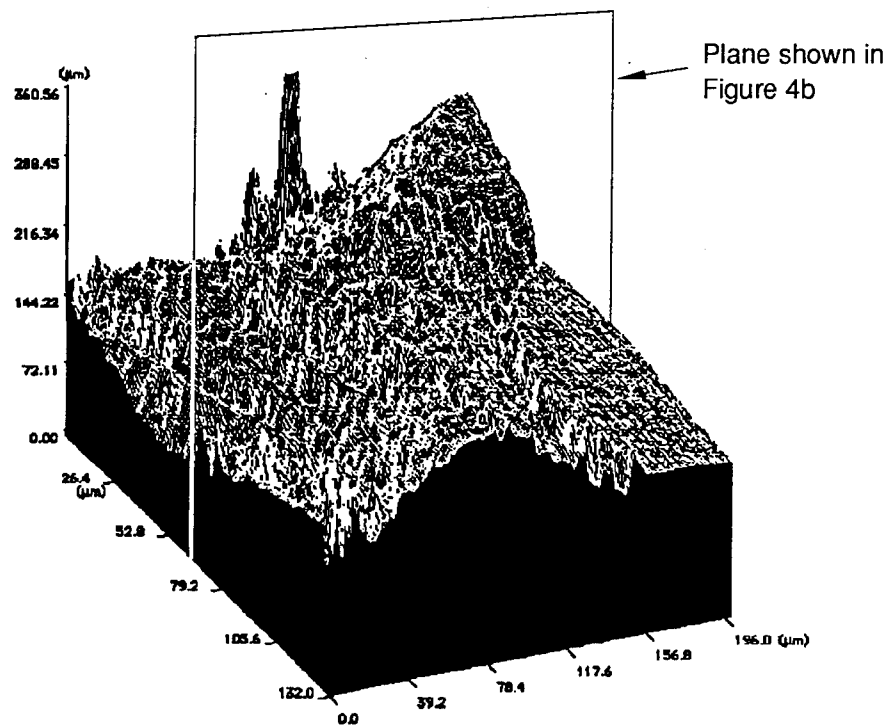
(a) Top fracture surface profile in Figure 4a (23°C test; Specimen 91-254)

(b) Bottom fracture surface profile in Figure 4a (23°C test; Specimen 91-254)

Figure 2.3. Fracture surface profiles measured with a scanning laser microscope.

(c) Top fracture profile in Figure 4b (815°C test; Specimen 91-247)

(d) Bottom fracture surface profile in Figure 4b (815°C test; Specimen 91-247)

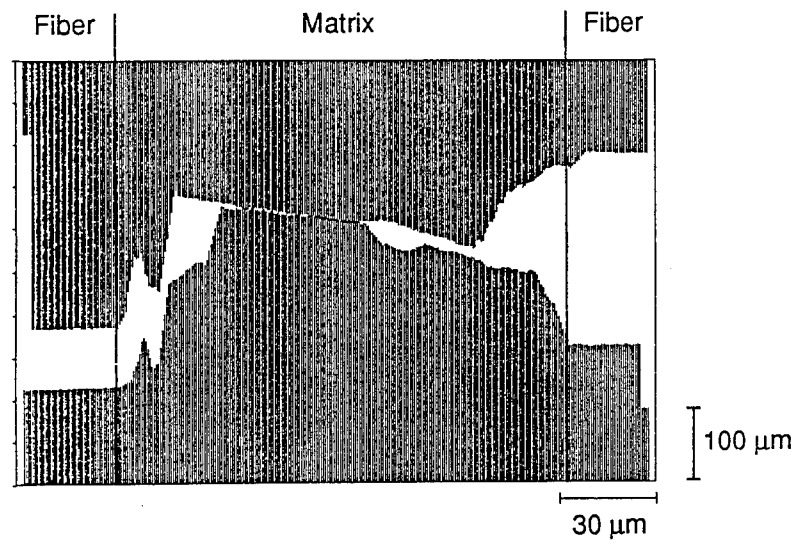
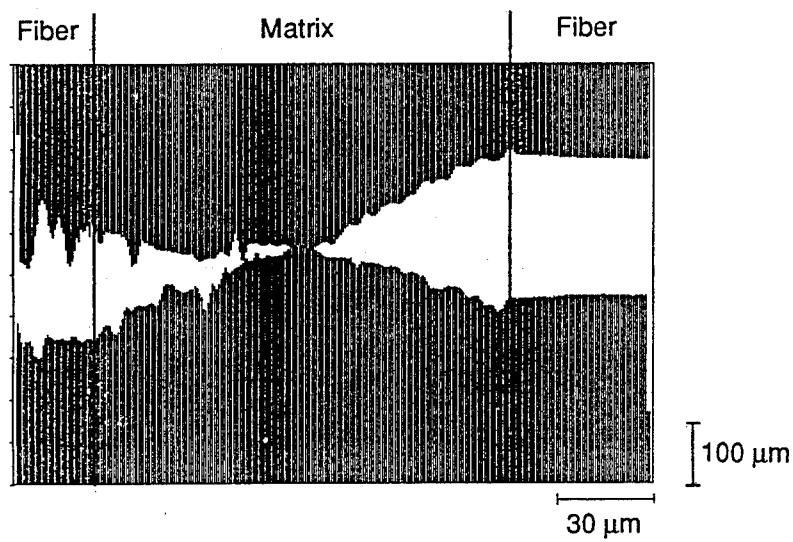
Figure 2.4. Conjugate fracture surface profile from $[0]_4$ tensile test specimens.

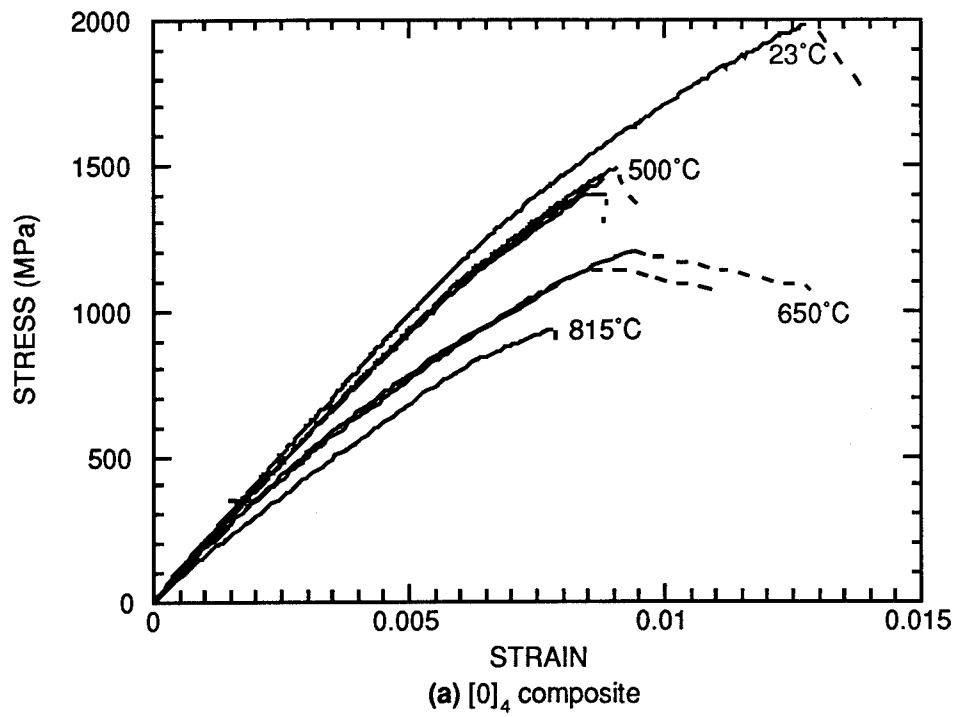
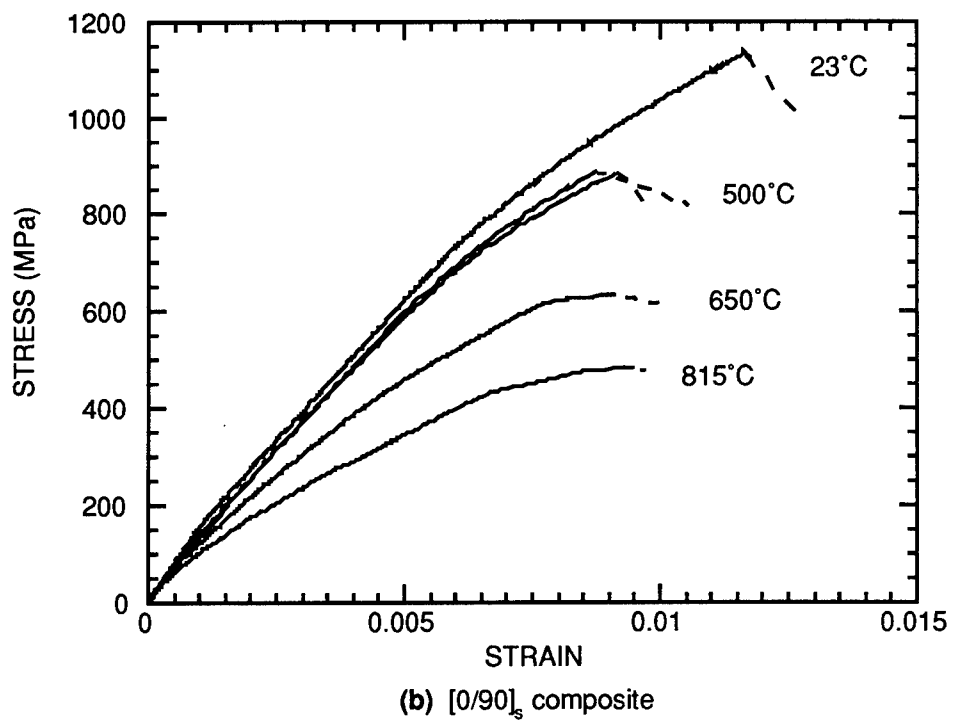
Figure 2.5. Stress-strain curves for SCS6/Timetal 21-S composite.

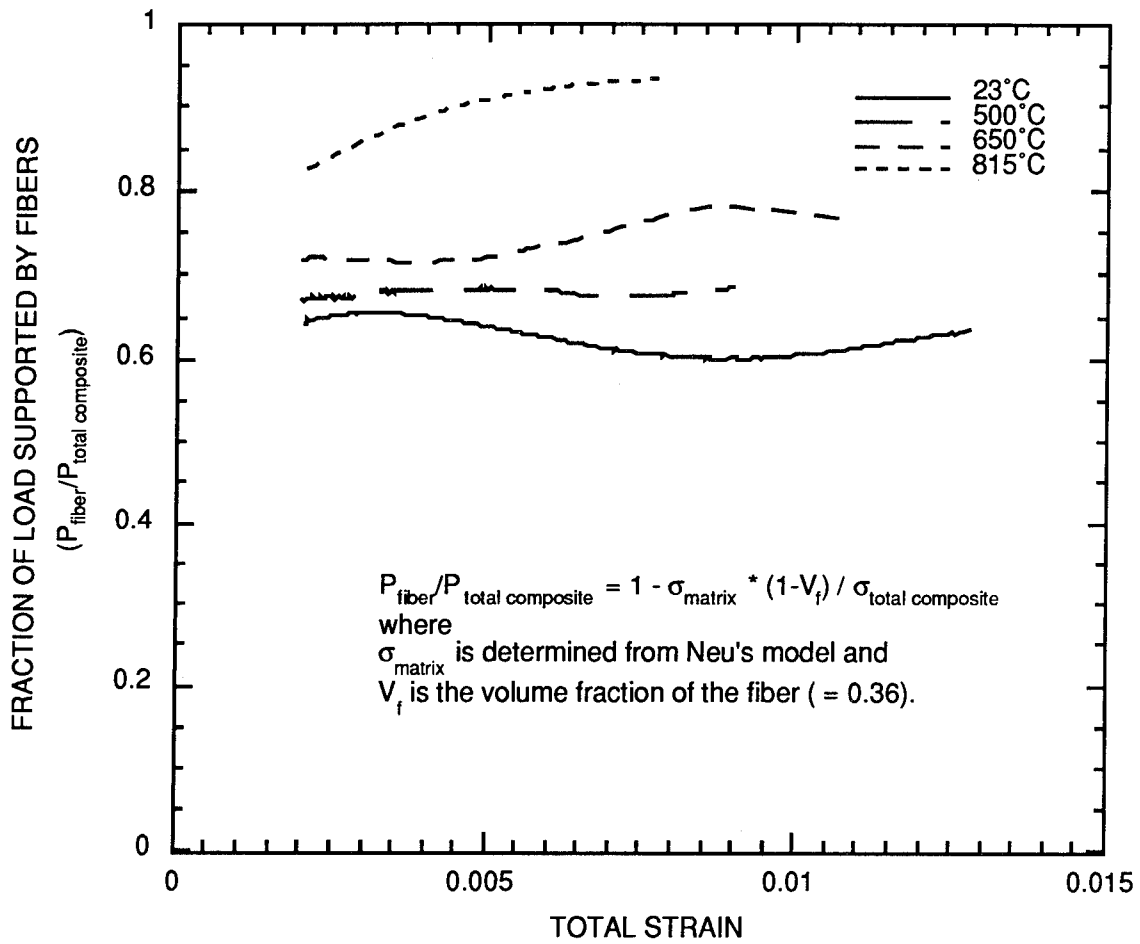
Figure 2.6. Fraction of the load supported by fibers in tensile tests on [0]₄ SCS6/Timetal 21-S composite.

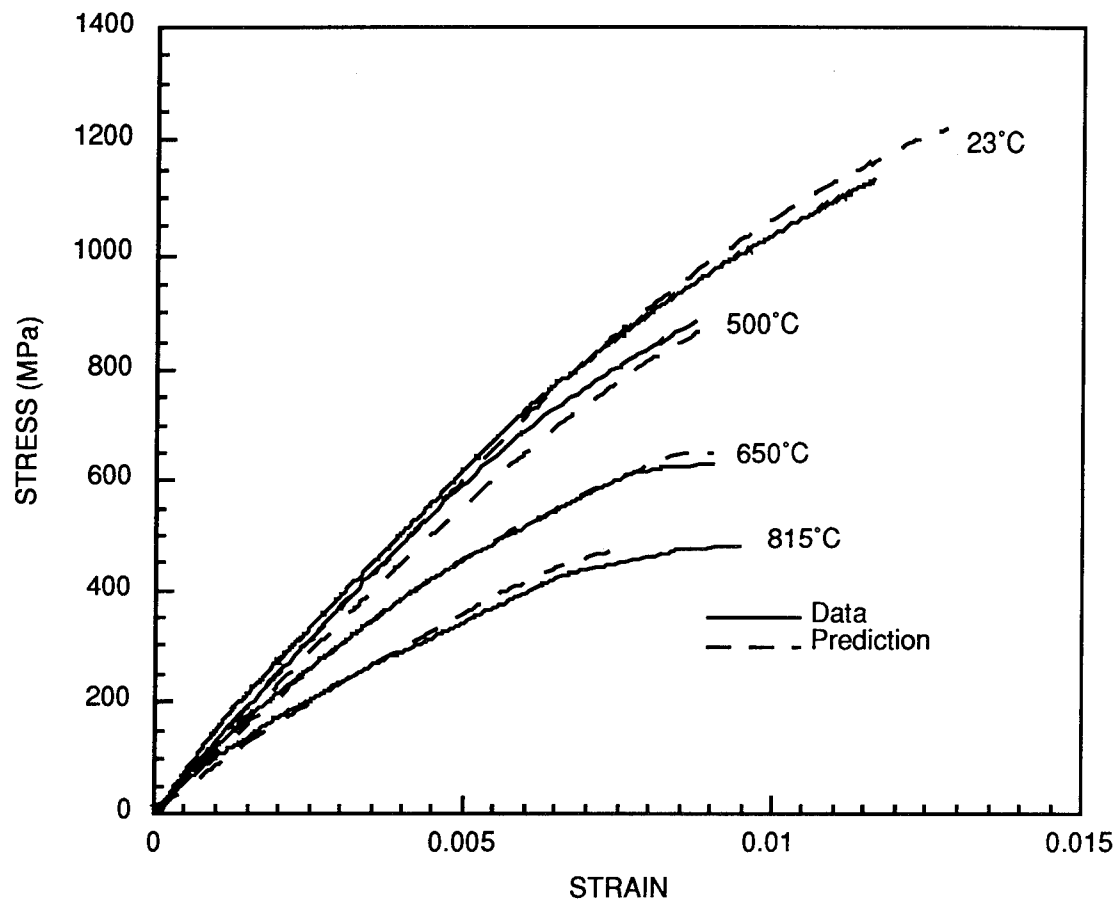
Figure 2.7. Comparison of measured and predicted stress-strain behavior for $[0/90]_s$ SCS6/Timetal 21-S composite based on $[0]_4$ data and Neu's model for Timetal 21-S.

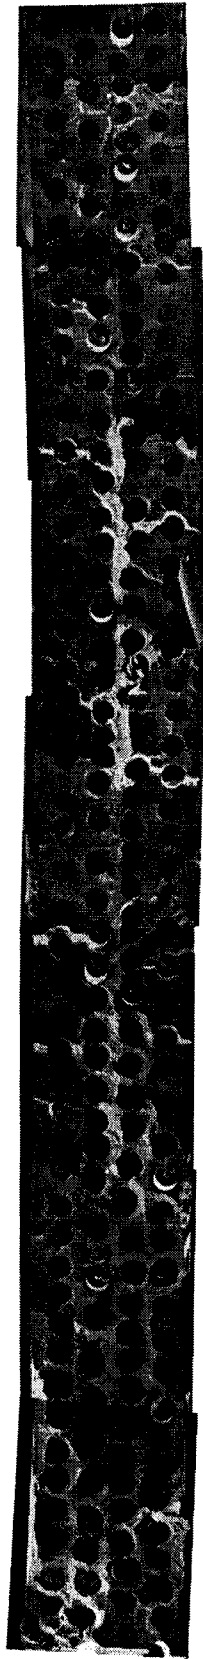
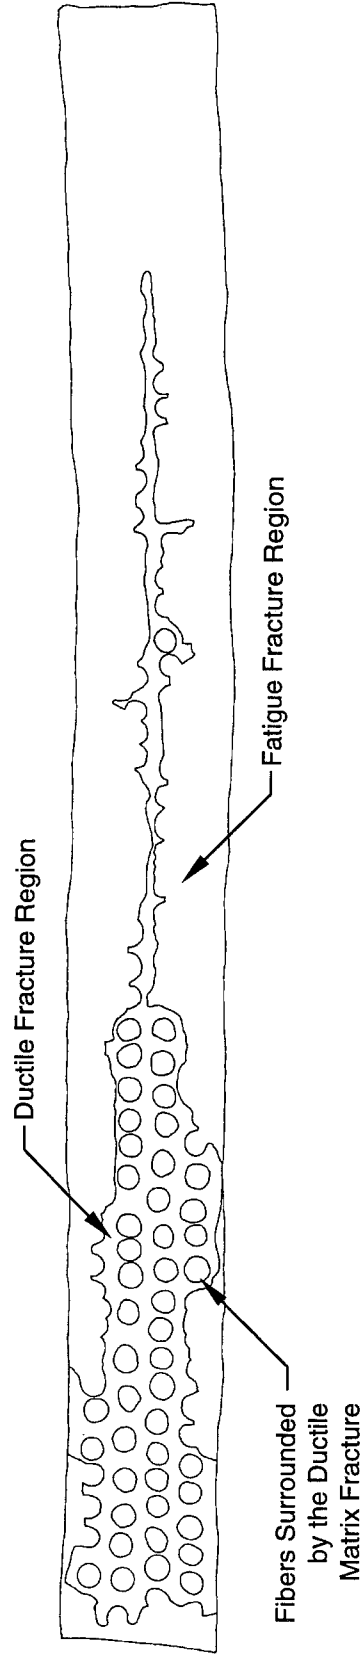
Figure 3.1 shows a fracture surface of the thermomechanical test specimen. The right side of the fracture surface is dominated by a fatigue-induced, flat fracture surface that extends from the outer surface of the specimen and penetrates toward the center. Neu and Nicholas² described the

(a) SEM Micrograph of Fracture Surface.

(b) Diagram Showing Regions of Fracture.

Figure 3.1. Fracture surface of thermomechanical test specimen.

As a first estimate, we considered all of the fibers that were surrounded by ductile matrix failure to be unbroken by the thermomechanical fatigue. Figure 3.1b shows the locations of the 48 fibers within the region of ductile matrix failure. Using a fiber strength of 3450 MPa reported by Ward, Herrmann, and Hillberry,¹⁰ we estimate the load supported by the 48 unbroken fibers to be 260 kg.

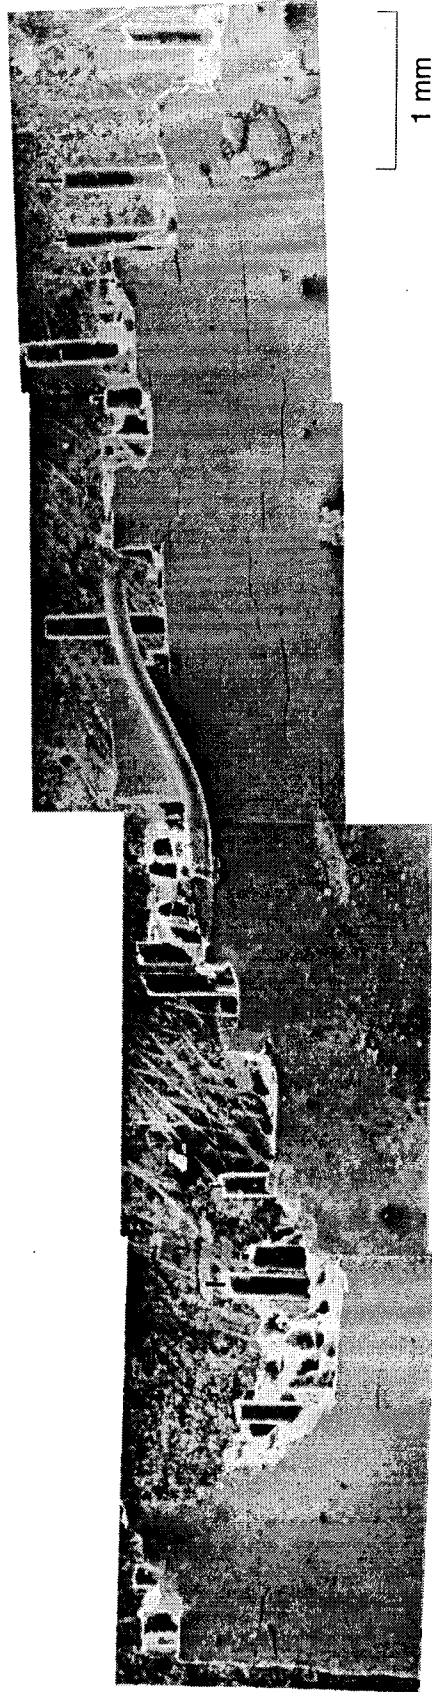
Figure 3.2. Side view of fracture surface.

As mentioned above, only those fibers that were completely surrounded by ductile matrix failure were assumed to contribute to the residual strength. Examination of Figure 3.1 revealed that 61 fibers are partially in contact with the ductile matrix failure region. If half of these fibers were unbroken (about 30), the estimated residual strength would be 793 kg, which is in good agreement with the maximum applied load (785 kg).

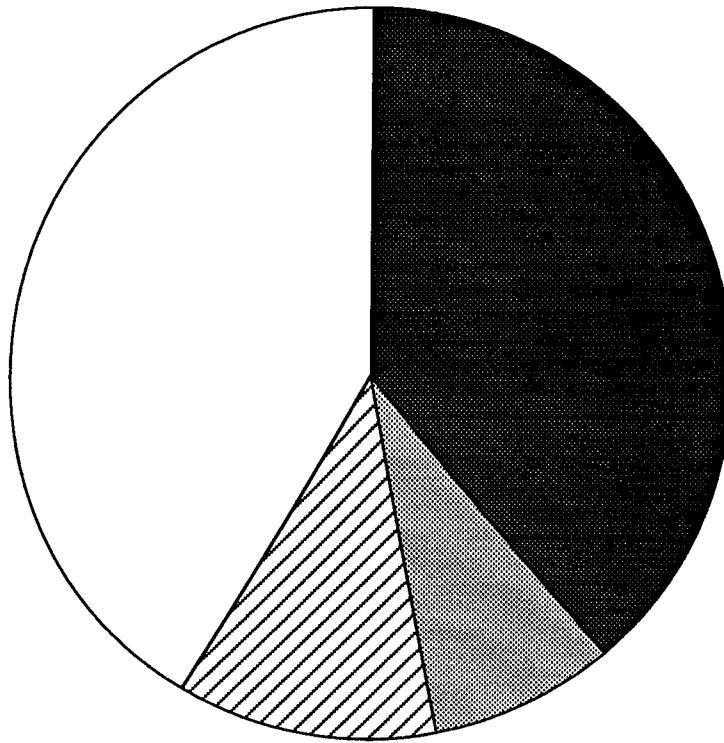
Total Calculated Load = 630 kg
Maximum Applied Load = 785 kg

- ☐ 260 kg Load from Fibers in Ductile Fracture Region
- ☒ 244 kg Load from Ductile Matrix Fracture Region
- ☒ 52 kg Load from Shear Fracture Region
- ☒ 74 kg Fiber/Matrix Friction Load

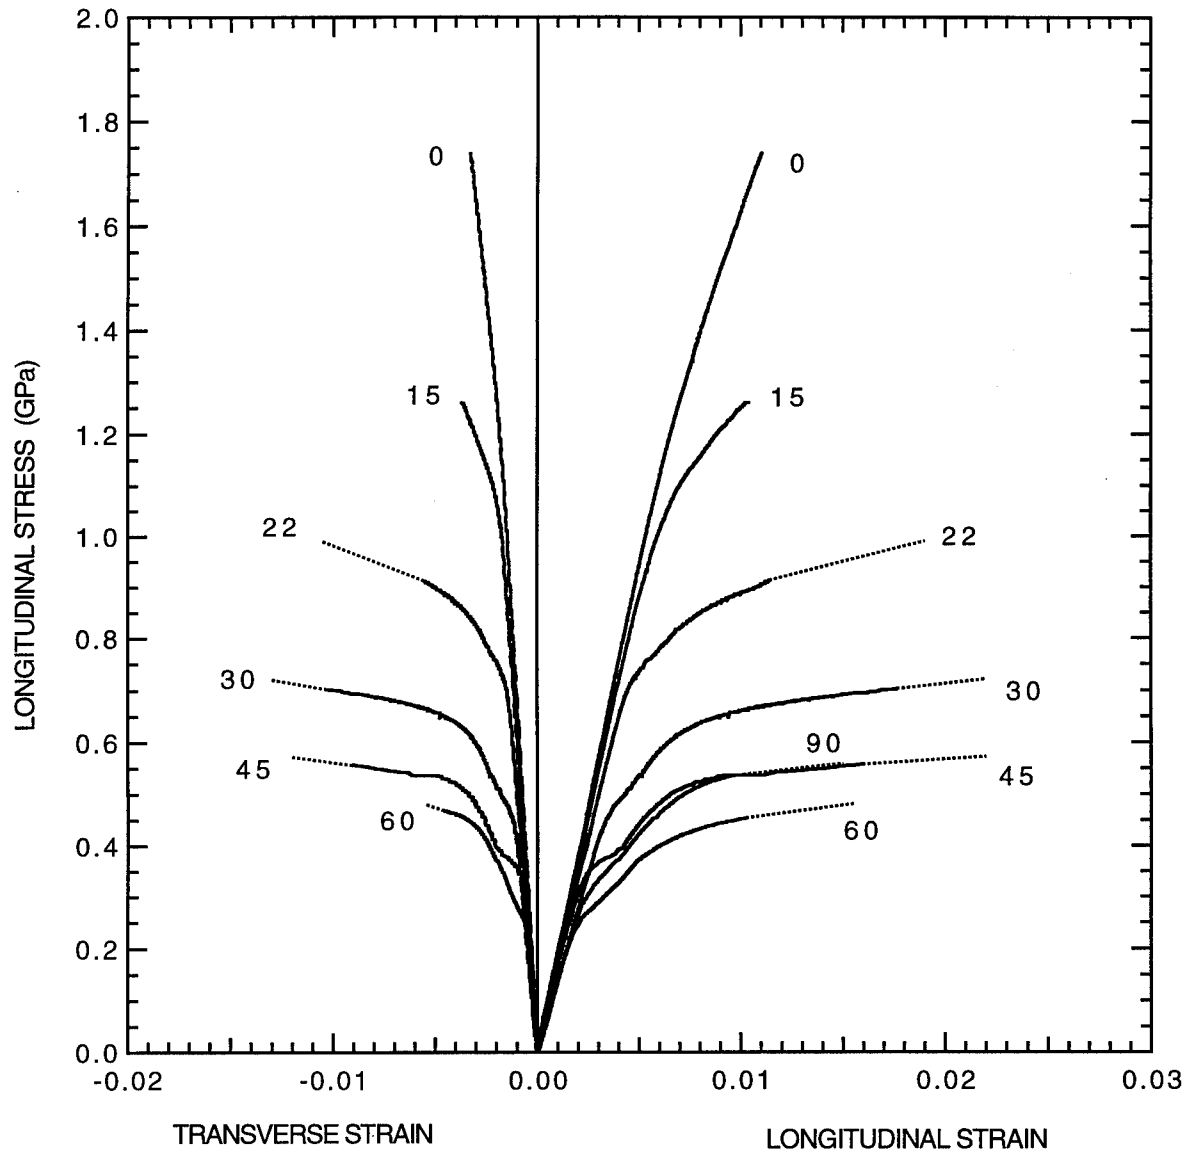
Figure 4.1. Measured stress-strain behaviors for the SCS6/Timetal 21-S off-axis tensile tests.

We used SEM and conventional metallography to establish the nature and extent of the damage in the specimens. The dominant failure mechanisms were fiber failure at the 0° and 15° orientations, matrix failure at the 30° through 90° orientations, and combined failure mechanisms at 22.5°. We used the replica film technique to observe the damage at various stages of the loading process on the polished edge of selected specimens. The replicas clearly show the failure and tensile opening of the fiber matrix interface in the 90° specimen in the nonlinear region of the stress-strain behavior.

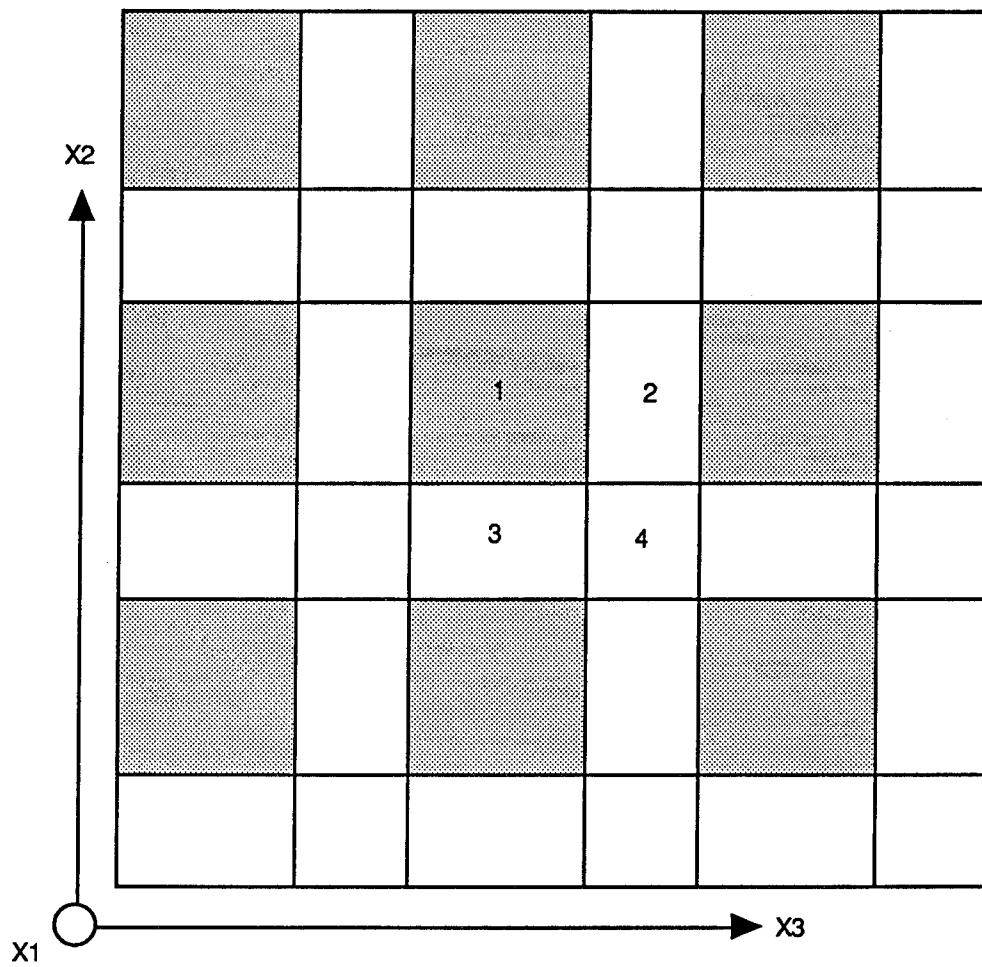
Figure 5.1. Subcell pattern for the generalized method of cells simulations of SCS6/Timetal 21-S composite.

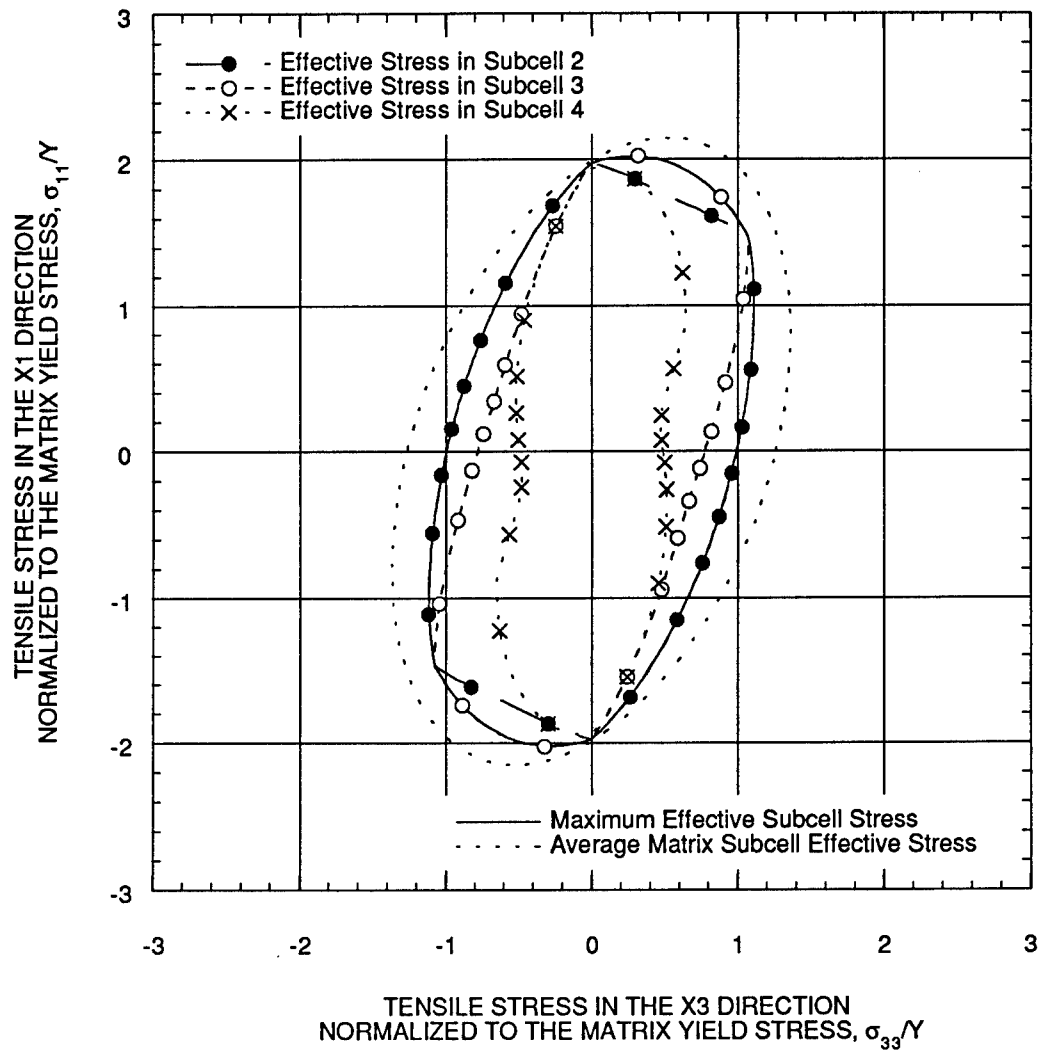
Figure 5.2. Method of cells simulation of the yield stress of SCS6/Timetal 21-S composite.

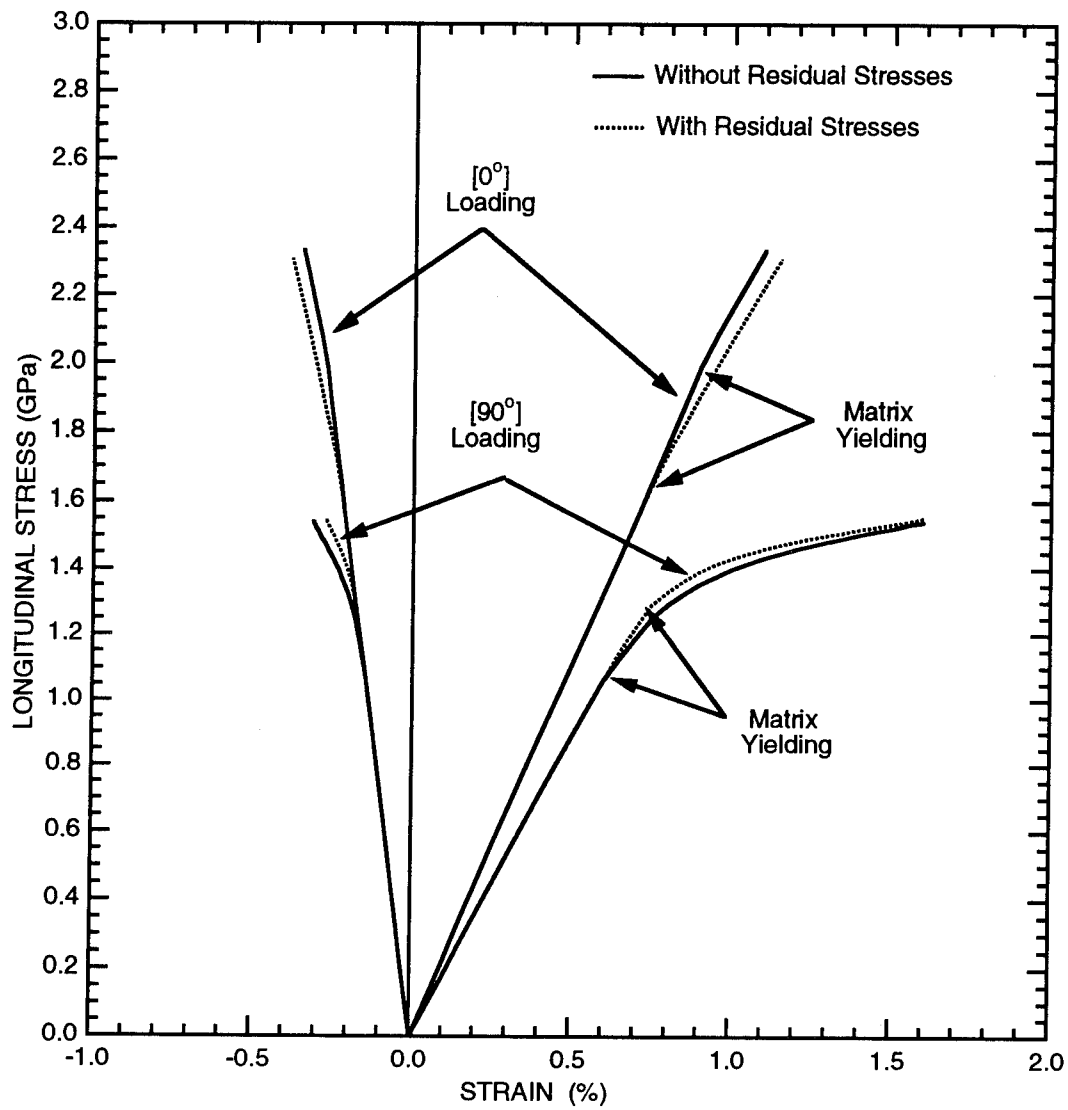
Figure 5.3. Generalized method of cells simulations of the effect of thermal residual stresses on the behavior of 0° and 90° SCS6/Timetal 21-S, assuming perfectly bonded fibers.

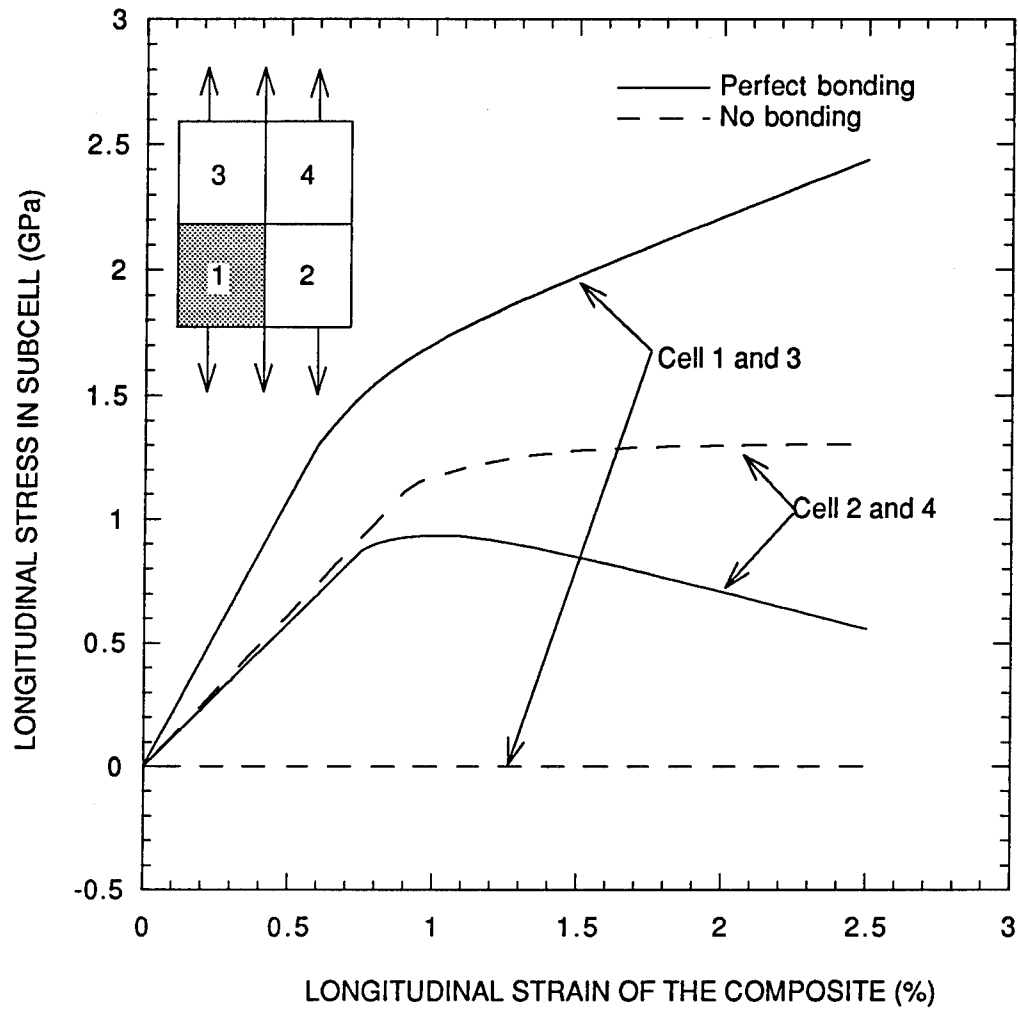
Figure 5.4. Cell response from simulations of the effect of fiber/matrix bonding in SCS6/Timetal 21-S composite.

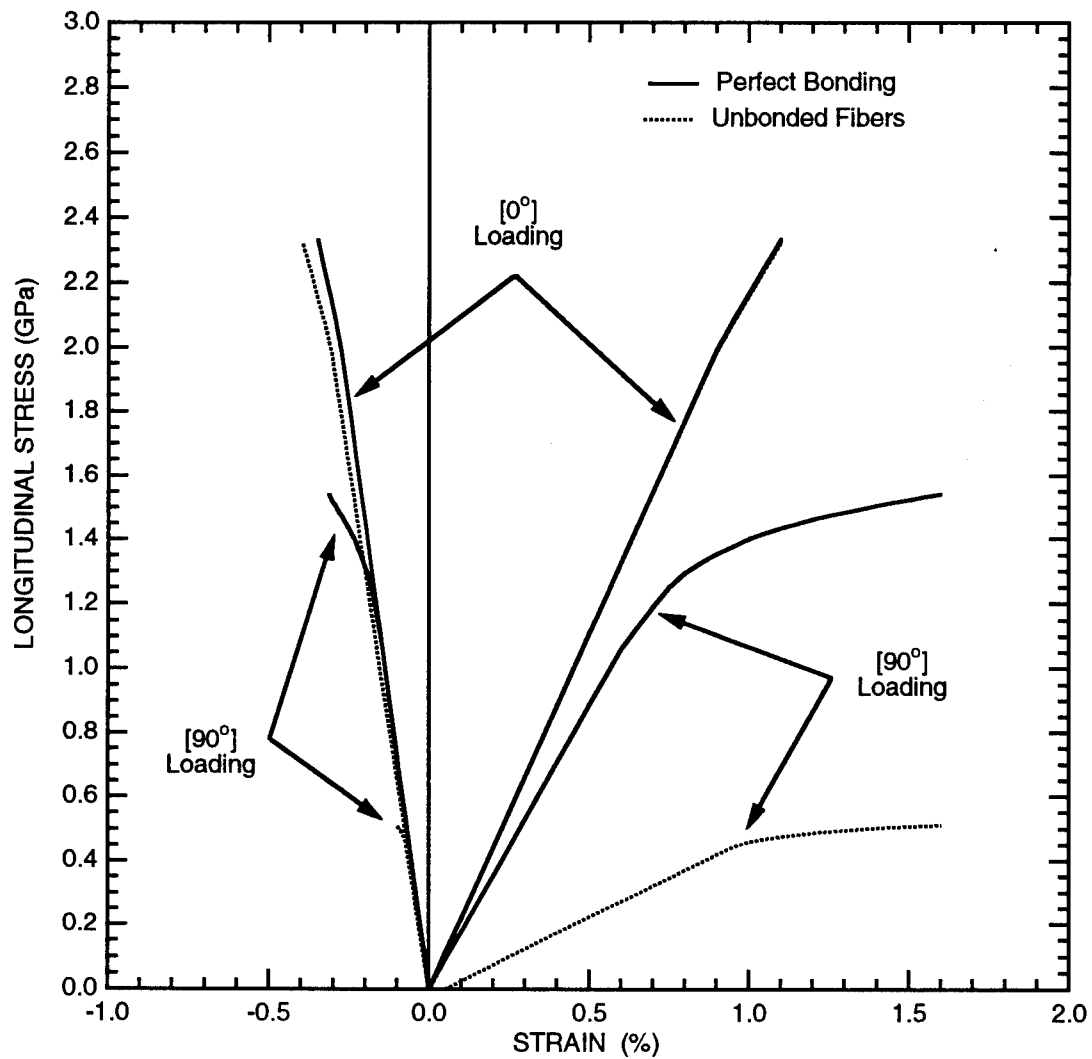
Figure 5.5. Generalized method of cells simulations of the effect of fiber/matrix interface bonding on the behavior of 0° and 90° SCS6/Timetal 21-S without thermal residual stresses.

The generalized method of cells results show substantial sensitivity of the yield to fiber/matrix bonding, especially under 90° loading. Furthermore, the generalized method of cells shows that residual stresses resulting from the cool down after fabrication lower the yield for 0° loading and slightly increase the yield under 90° loading. These trends are in qualitative agreement with expectations and with finite element simulations for the comparisons made thus far. Thus, the generalized method of cells is able to simulate the basic features of the composite response. Further comparisons are needed to bound the level of accuracy and physical reasonableness of the model.

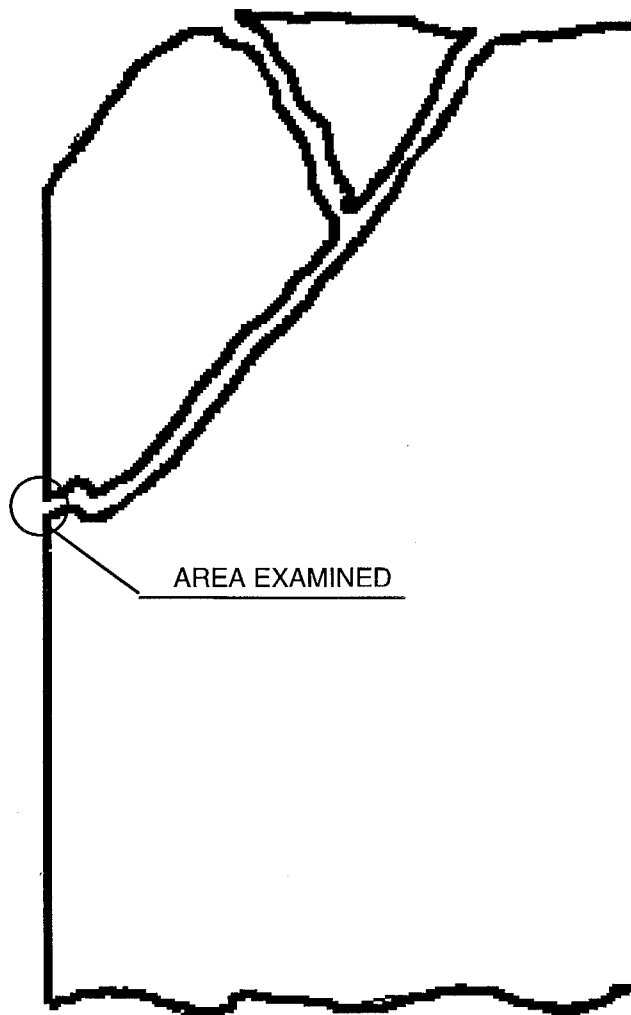
Figure A.1. Sketch showing fracture pattern and the location where FRASTA was applied.
